Property Inspection Report

Property Located At: 1234 Apple Drive, Anytown, MD 217XX

# Property Analysis Report

Absolute Home Inspections, LLC  
17129 Lappans Road, Hagerstown, MD 21740-1338

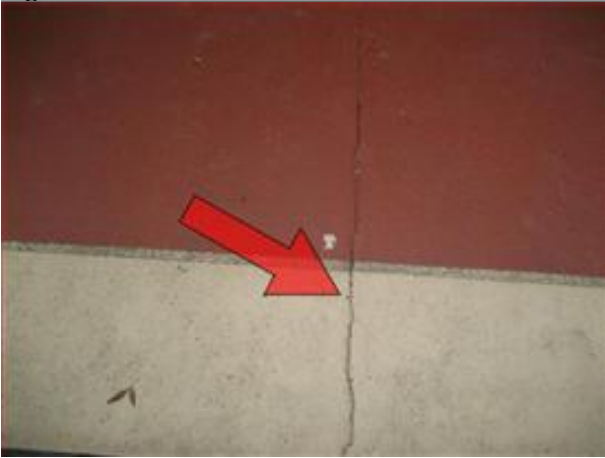
Figure Number 1

Observed three settlement cracks in the front sidewalk; two in the sidewalk and one at the step up to the sidewalk. Recommend removing any loose debris in the cracks and sealing them with cement to prevent further damage from water intrusion and freezing and thawing.

2. Observed three settlement cracks in the front sidewalk; two in the sidewalk and one at the step up to the sidewalk. Recommend removing any loose debris in the cracks and sealing them with cement to prevent further damage from water intrusion and freezing and thawing. (See Figure #1) (See Figure #2)

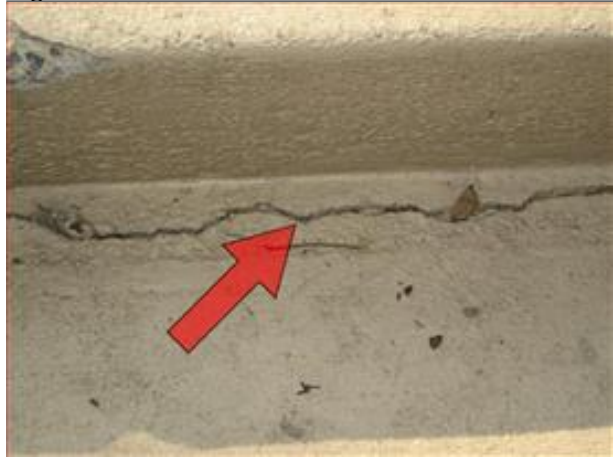
Figure Number 2

Observed three settlement cracks in the front sidewalk; two in the sidewalk and one at the step up to the sidewalk. Recommend removing any loose debris in the cracks and sealing them with cement to prevent further damage from water intrusion and freezing and thawing.

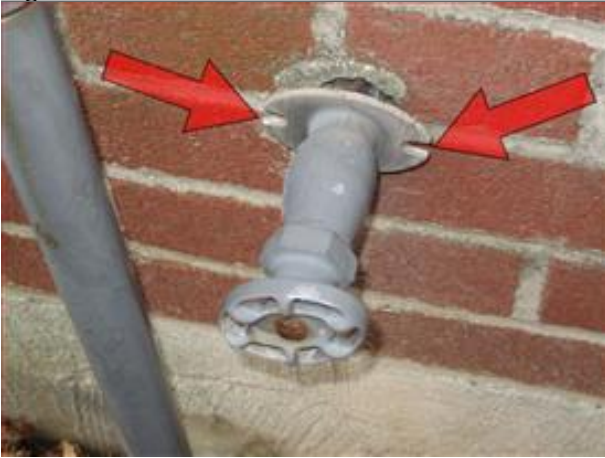
Figure Number 3

Noted the hose bib on the right side of the property is not secured to the exterior wall. The copper supply pipe can be damaged just from normal use. Recommend fastening the hose bib with "Tapcon" hardened masonry screws for stability and to prevent damage to the water pipe.

3. Noted the hose bib on the right side of the property is not secured to the exterior wall. The copper supply pipe can be damaged just from normal use. Recommend fastening the hose bib with "Tapcon" hardened masonry screws for stability and to prevent damage to the water pipe. (See Figure #3)

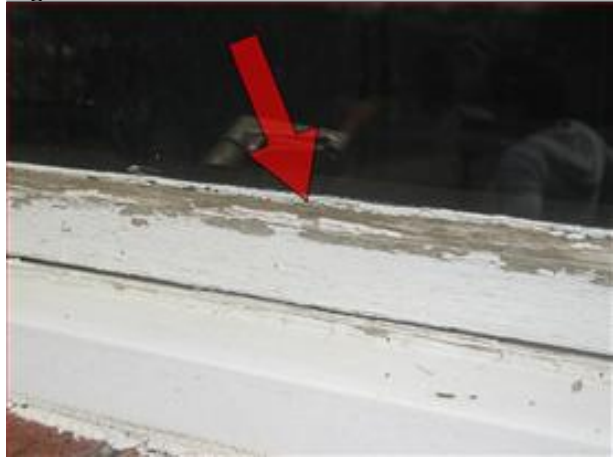
Figure Number 4

Recommend scraping, priming and painting the exterior wood trim at the Kitchen window to extend the wood life.

Light Fixtures	<input type="checkbox"/> N/V <input checked="" type="checkbox"/> OK Observation: Not Operational / Loose at Wall Connection / Exposed Wires / Missing Components / Damaged Bulb(s)
Paints / Sealants	<input type="checkbox"/> OK <input checked="" type="checkbox"/> Recommend Upgrading to Prevent Water Intrusion <u>Observation:</u> Missing / Peeling / <a href="#">Weathered</a> <u>Located at:</u> <a href="#">Windows</a> / Doors / Trim / Fascia
Caulk	<input checked="" type="checkbox"/> OK <input type="checkbox"/> Recommend Upgrading to Prevent Water Intrusion Observation: Loose / Missing / Cracking / Weathered Located at: Windows / Doors / Trim / Fascia
Remarks	<ol style="list-style-type: none"> <li>1. Recommend scraping, priming and painting the exterior wood trim at the Kitchen window to extend the wood life. (See Figure #4)</li> <li>2. See Summary Remarks</li> </ol>

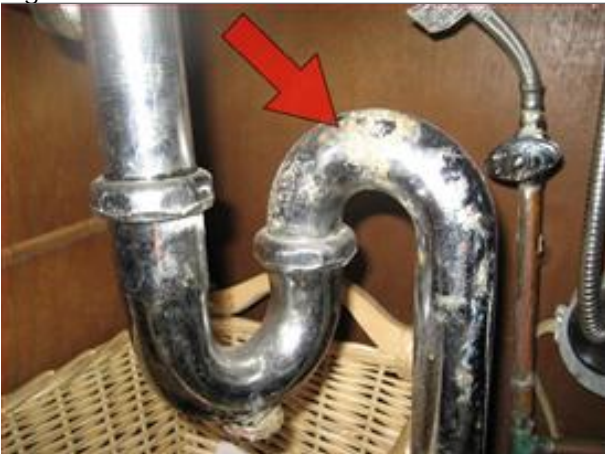
Figure Number 5

Observed corrosion at the metal drain pipes under the kitchen and half bath sinks; no leaks were noted at this time. Recommend replacing the metal drains with PVC as preventive maintenance.

1. Observed corrosion at the metal drain pipes under the kitchen and half bath sinks; no leaks were noted at this time. Recommend replacing the metal drains with PVC as preventive maintenance. (See Figure #5) (See Figure #6)

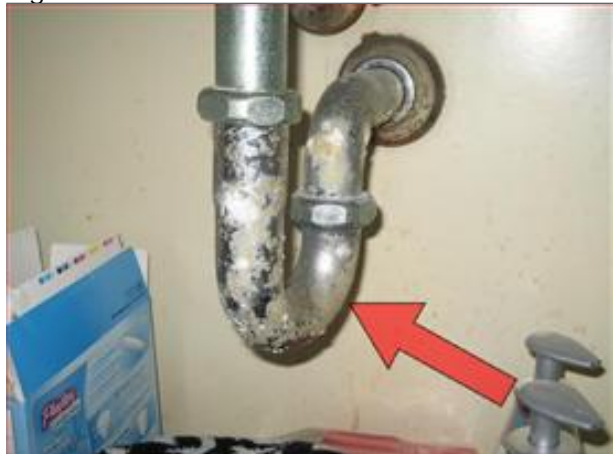
Figure Number 6

Observed corrosion at the metal drain pipes under the kitchen and half bath sinks; no leaks were noted at this time. Recommend replacing the metal drains with PVC as preventive maintenance.

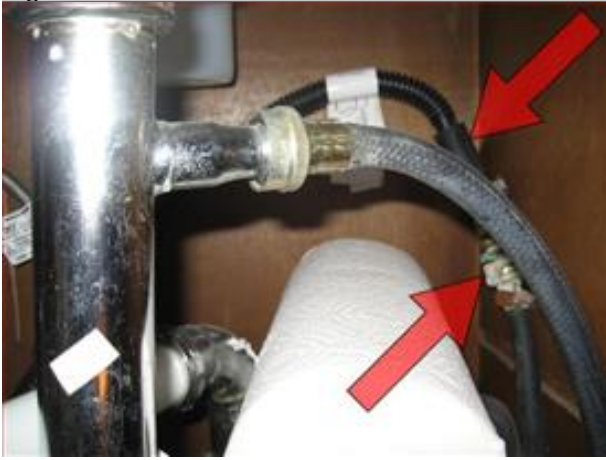
Figure Number 7

Recommend eliminating the excess drain hose for the dishwasher. Remove the black rubber hose that is connected to the black flex drain hose and connect the black flex hose to the sink drain making sure the drain hose is secured to the cabinet wall so the the highest arc in the hose is above the connection at the drain to prevent the possibility of a cross connection.

Floor	<input checked="" type="checkbox"/> OK <input type="checkbox"/> Sheet Goods <input checked="" type="checkbox"/> Hardwood <input type="checkbox"/> Laminate Wood <input type="checkbox"/> Ceramic Tile <input type="checkbox"/> Carpet Observation: Torn / Burned / Loose / Damaged Tiles / Heavy Wear
Remarks	<ol style="list-style-type: none"> <li>1. Recommend eliminating the excess drain hose for the dishwasher. Remove the black rubber hose that is connected to the black flex drain hose and connect the black flex hose to the sink drain making sure the drain hose is secured to the cabinet wall so the the highest arc in the hose is above the connection at the drain to prevent the possibility of a cross connection. (See Figure #7)</li> <li>2. See Summary Remarks</li> </ol>

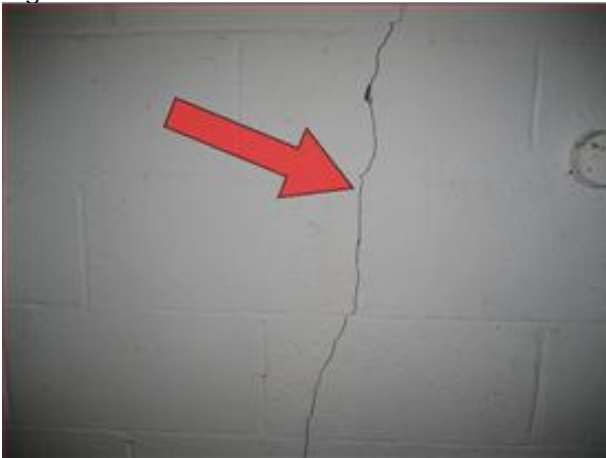
Figure Number 9

A vertical crack was observed at the left rear corner of the property. This crack is not the typical "stair-stepping" crack that can be attributed to settlement. It has cracked the bricks and carries on down into the concrete block of the garage foundation wall. Recommend further evaluation by a qualified foundation contractor to determine the severity of this crack.

1. A vertical crack was observed at the left rear corner of the property. This crack is not the typical "stair-stepping" crack that can be attributed to settlement. It has cracked the bricks and carries on down into the concrete block of the garage foundation wall. Recommend further evaluation by a qualified foundation contractor to determine the severity of this crack. (See Figure #8) (See Figure #9)
2. Recommend installing a CO (Carbon Monoxide) detector in the basement and on the main level since there is natural gas supply to the property and a wood burning fireplace. Also, recommend replacing the batteries in the smoke detectors. SAFETY
3. Recommend having the fireplace chimney professionally cleaned prior to use. SAFETY

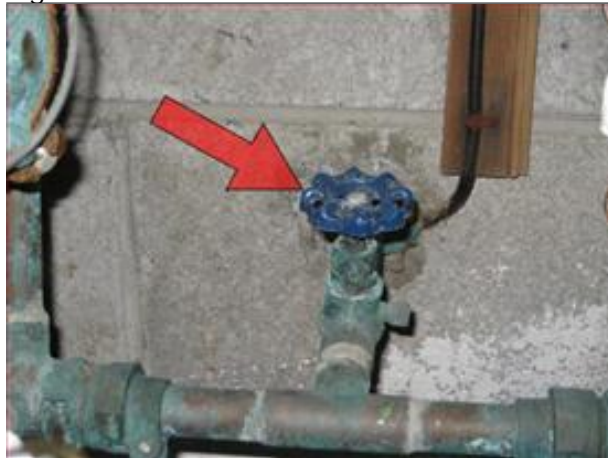
Figure Number 10

The main water "SHUT-OFF" valve is located at the inside of the right side basement wall near the water meters. (Blue handle)

1. The main water "SHUT-OFF" valve is located at the inside of the right side basement wall near the water meters. (Blue handle) (See Figure #10)
2. Recommend steel braided hoses for water supply to the washer.

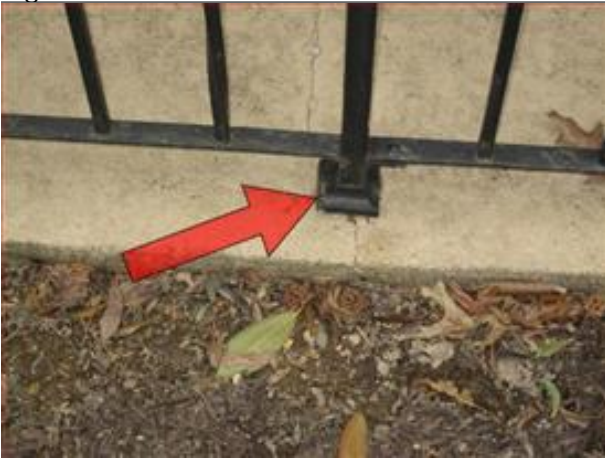
Figure Number 11

Noted the base of one of the metal handrail supports on the front sidewalk railing is loose (located at the crack in the walk). Recommend re-securing the support post base to the sidewalk with "Tapcon" hardened masonry screws for stability. SAFETY

4. Noted the base of one of the metal handrail supports on the front sidewalk railing is loose (located at the crack in the walk). Recommend re-securing the support post base to the sidewalk with "Tapcon" hardened masonry screws for stability. SAFETY (See Figure #11)
